Fluvial Geomorphology and Erosion Hazard Assessment

Tay River and Grants Creek
141 Peter Street
Perth, Ontario

February 19, 2023
PN22029

Report Title: Fluvial Geomorphology and Erosion Hazard Assessment
Tay River and Grants Creek
141 Peter Street – Perth, Ontario

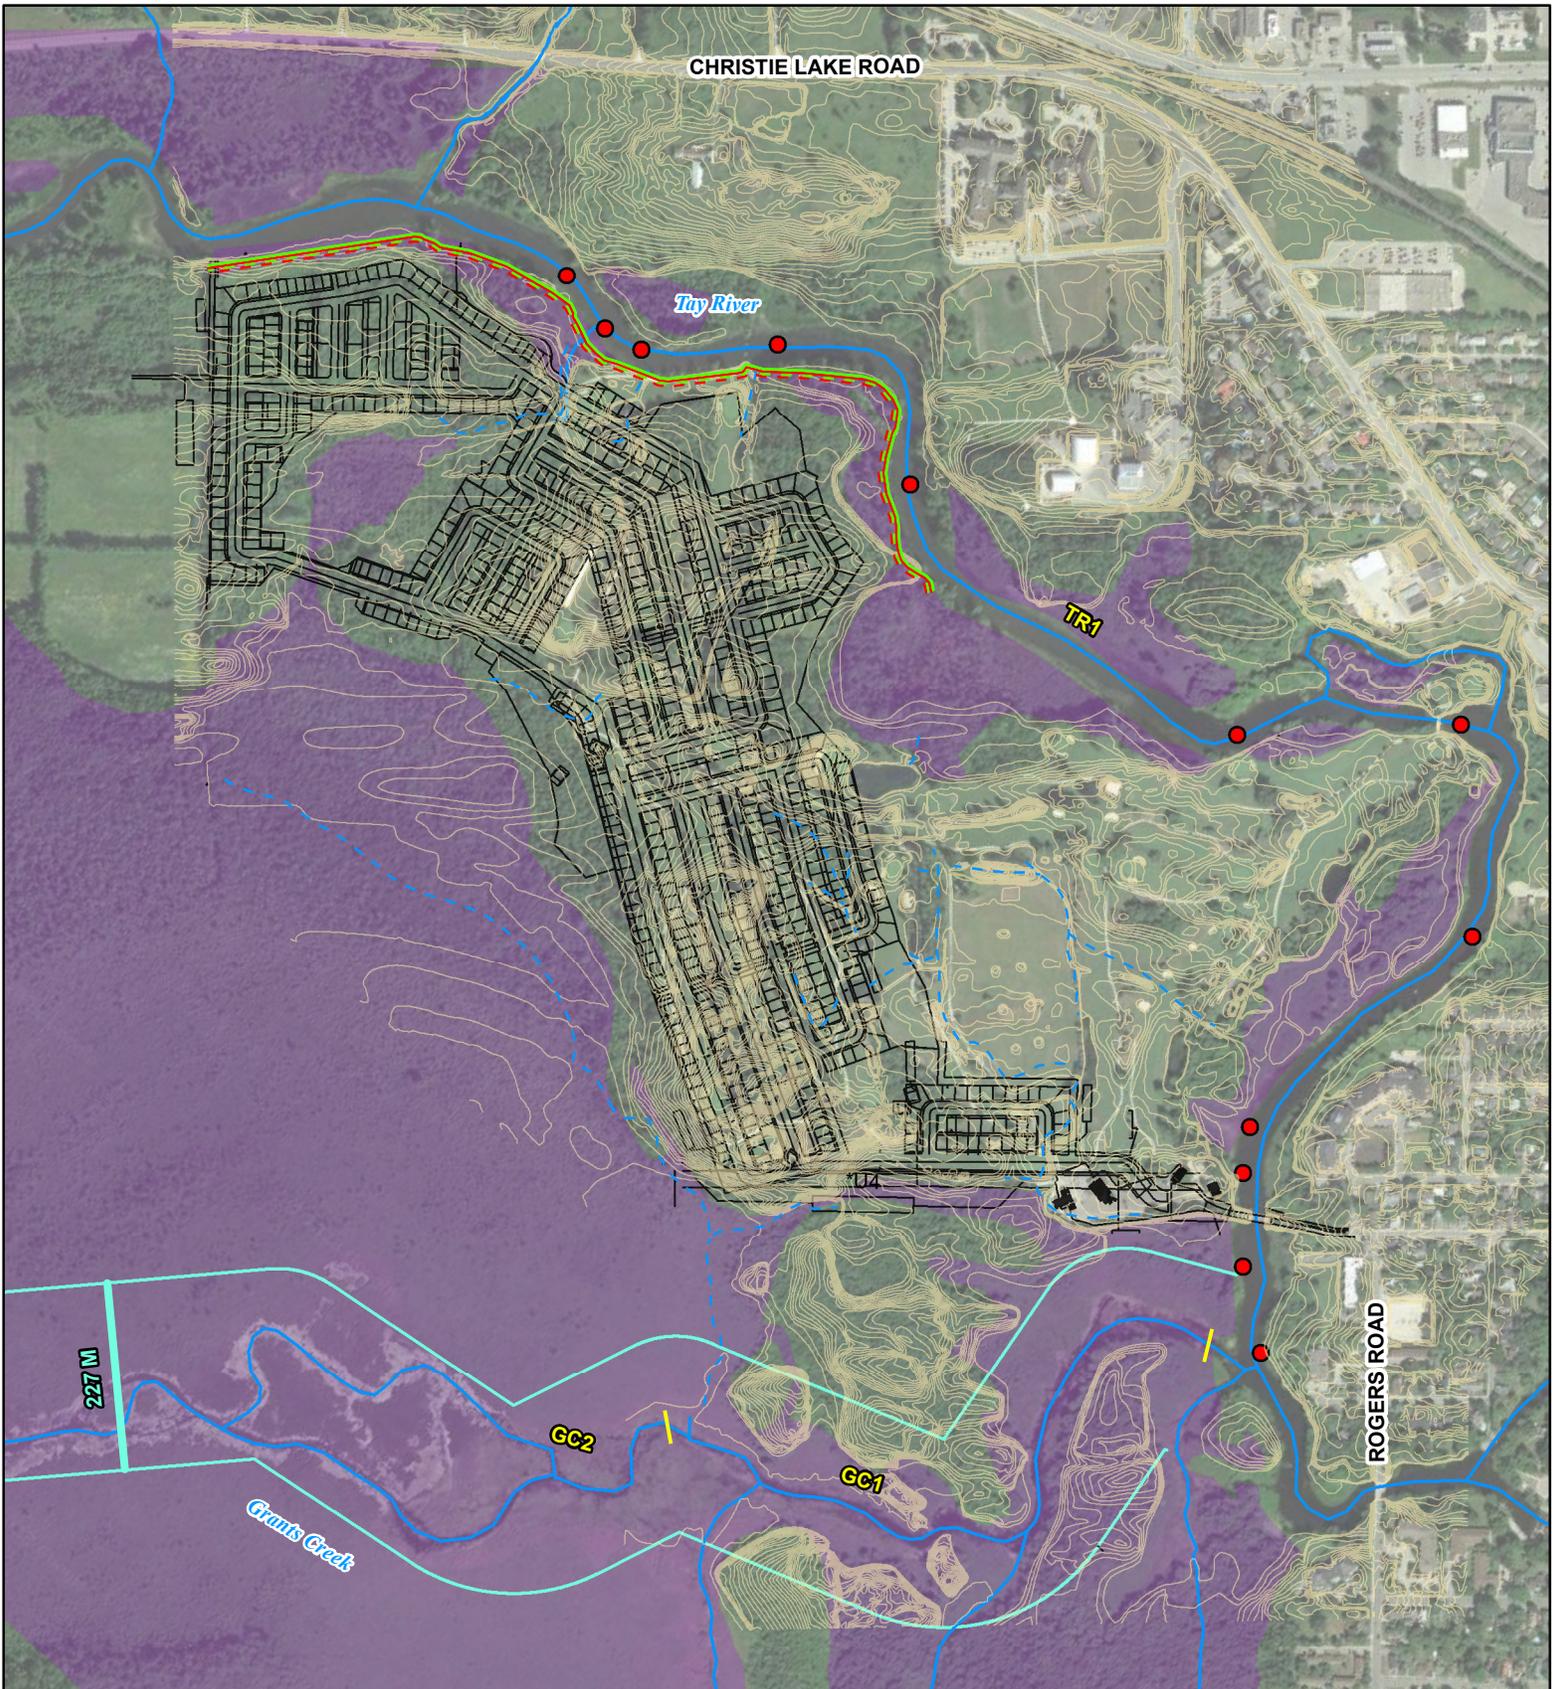
**Study Area and
Erosion Hazard Delineation**
Tay River and Grants Creek
Perth, Ontario

To delineate the meander belt width for Grants Creek, several meander bends were reviewed through desktop assessment using historical and recent aerial imagery. The largest meander amplitude of 189 m was measured in a 2019 aerial photograph immediately south of the proposed development lands. A twenty percent factor of safety was added to the largest meander amplitude, resulting in a final meander belt width of 227 m. The final meander belt width for Grants Creek is graphically represented in **Appendix A**.

Based on MNRF (2002) guidelines and the presence of bedrock along the channel, a 2-5 m toe erosion allowance is recommended for the Tay River. We understand that a geotechnical slope stability assessment was completed by GEMTEC (2023) which recommended an 8 m toe erosion allowance for the channel based on observations of clay/silt, granular, and organic overlays across the bedrock on site. During our field reconnaissance, we observed numerous areas of exposed bedrock along the channel and channel banks. Given the exposed bedrock along the reach, we would suggest that a reduced toe erosion allowance of 5 m would also be an appropriate approach to address the erosion hazard for the Tay River. Both the 5 m and 8 m toe erosion allowances are plotted in **Appendix A**, for reference. An additional 6 m erosion access allowance has also been applied to both. Note that in both cases, the erosion hazard setback and associated access allowance do not impact the proposed development fabric for the Subject Lands.

A toe erosion allowance of 8 m was recommended for the Tay River through a slope stability assessment (GEMTEC, 2023) to address the erosion hazard associated with the confined river system. Based on MNR (2002) guidelines, we agree that the 8 m setback is appropriate to address the erosion hazard. Although, based on our field observations of bedrock outcrops along the channel and channel banks, we would suggest that a reduced toe erosion allowance of 5 m would also be appropriate. Both recommendations are still conservative given that the watercourse is not expected to migrate laterally due to the geological constraint created by the existing bedrock on site.

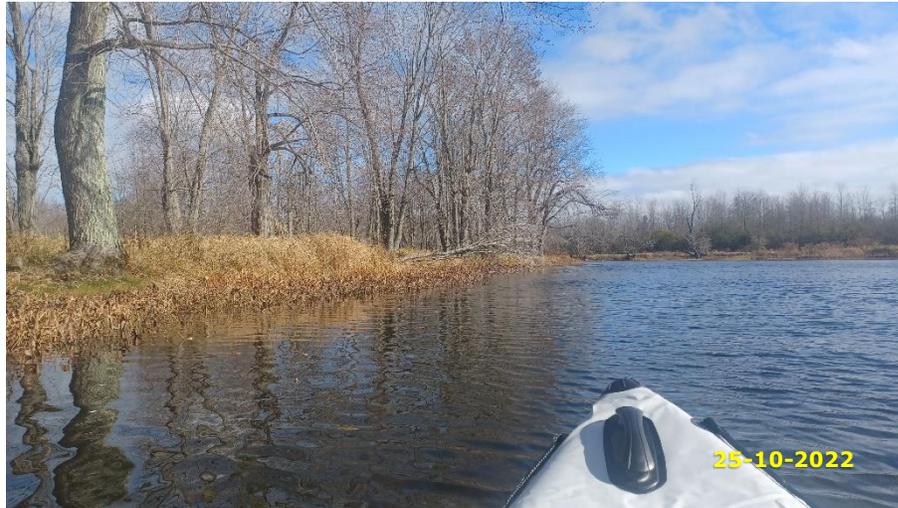
Photo 1
Tay River

A view of the Tay River channel and north bank near the upstream extent of the Perth Golf Course; perspective is facing south and downstream.

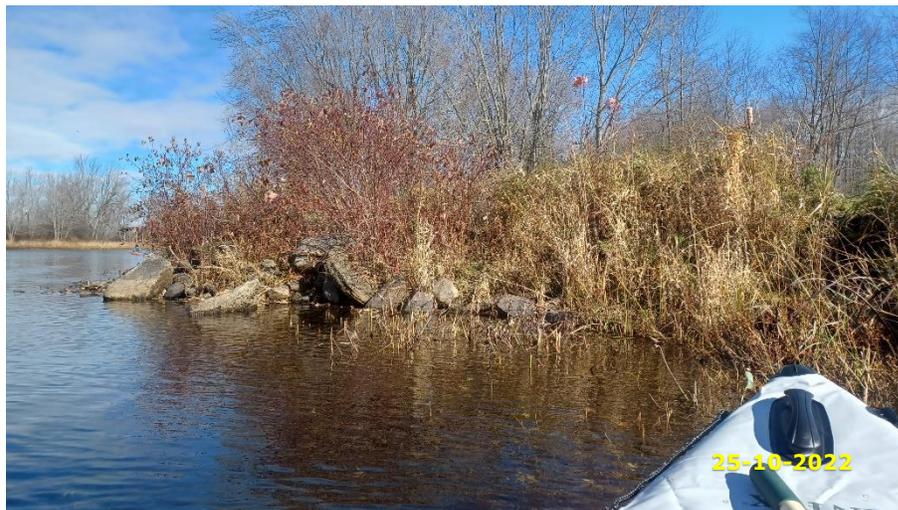
Photo 2
Tay River

Bedrock outcrop along the south bank of the Tay River, which borders the northwestern extent of the golf course; perspective is facing east and downstream.

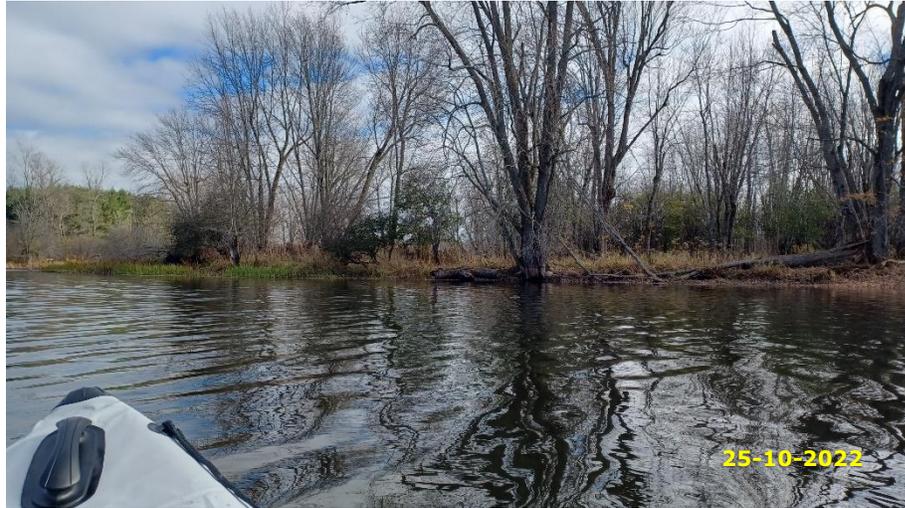
Photo 3
Tay River

Trees and vegetation along a low-lying, marsh area bordering the golf course within the floodplain along the south bank; perspective is facing south.

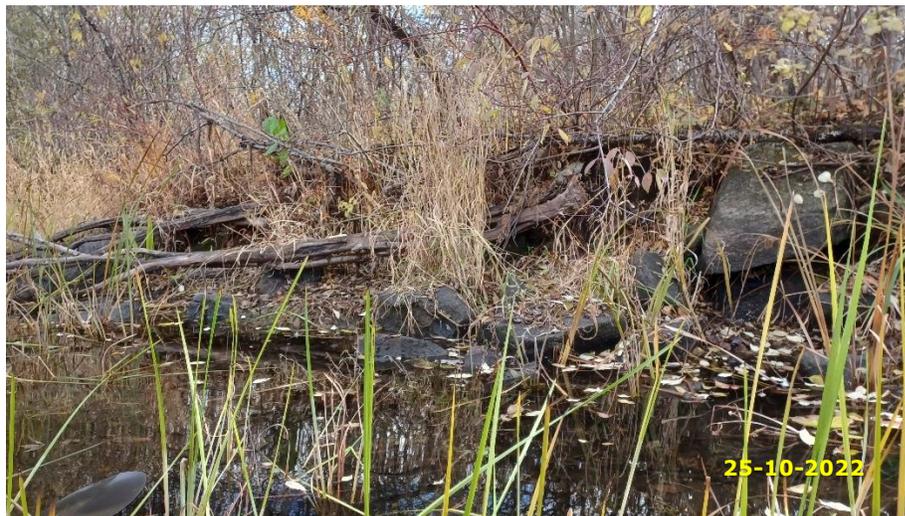
Photo 4
Tay River

Bedrock outcrop along the south bank, which borders the northwestern extent of the golf course; perspective is facing south.

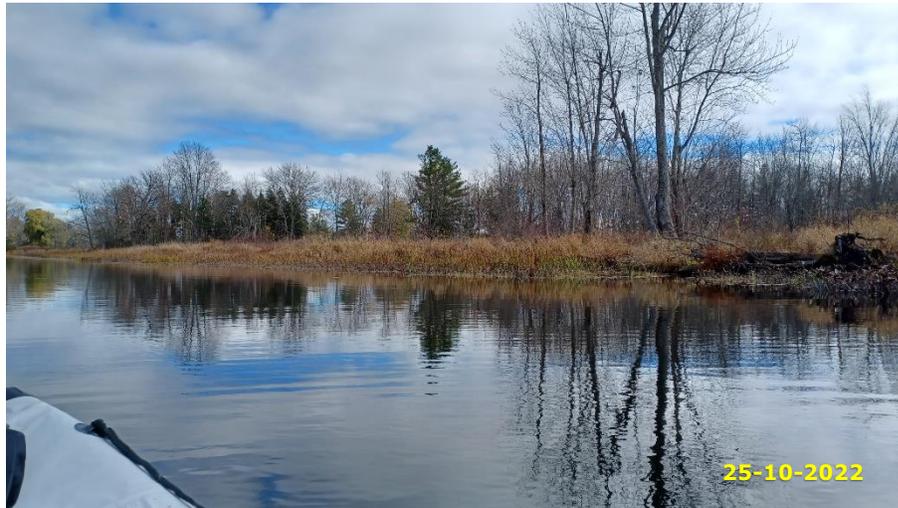
Photo 5
Tay River

Trees and vegetation along a low-lying, marsh area bordering the golf course within the floodplain along the south bank; perspective is facing south.

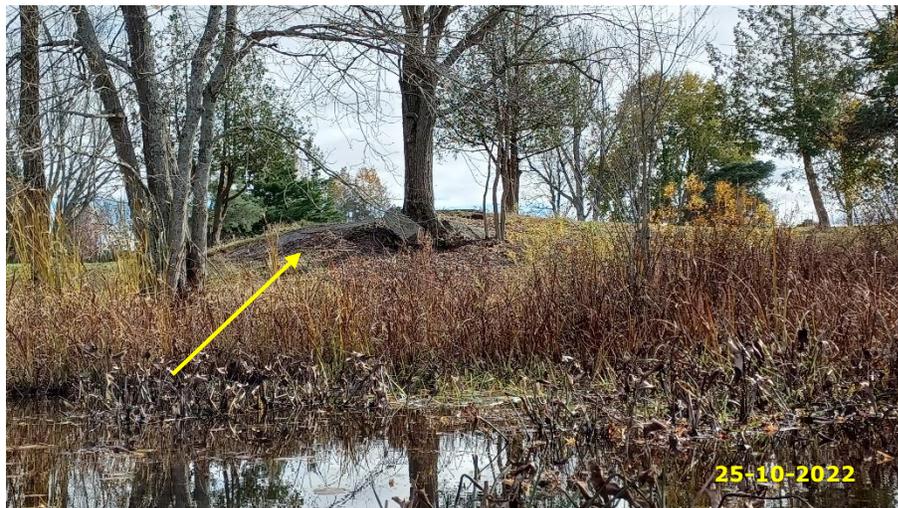
Photo 6
Tay River

Bedrock outcrop (yellow arrow) near the base of a mature tree along the south bank.

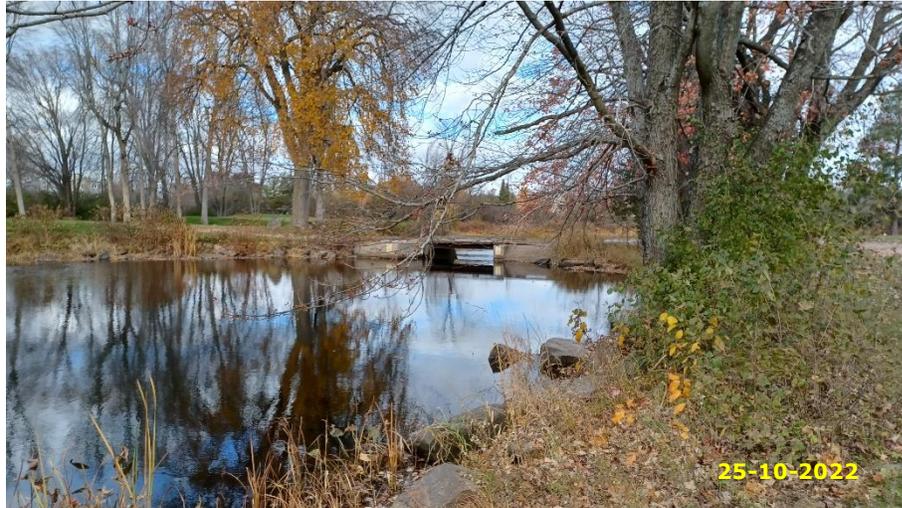
Photo 7
Tay River

A small weir with an approximately 1 m drop is located under a bridge crossing over the Tay River adjacent to the most northern point of the golf course. We understand that a lock system and several dams are also located downstream within the Town of Perth.

A weir with an approximately 1-meter drop under a bridge crossing causing a backwatering effect; perspective is facing east downstream.

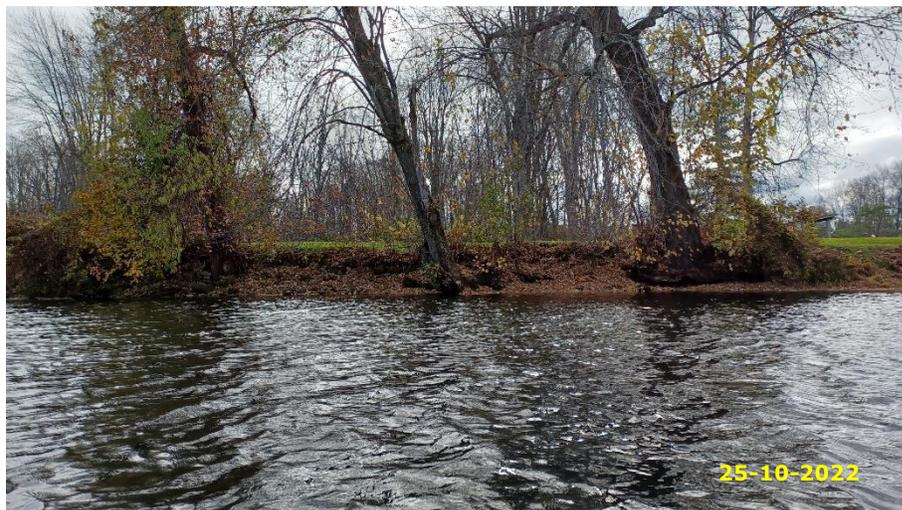
Photo 8
Tay River

Leaning trees along the southwest bank just downstream of the weir.

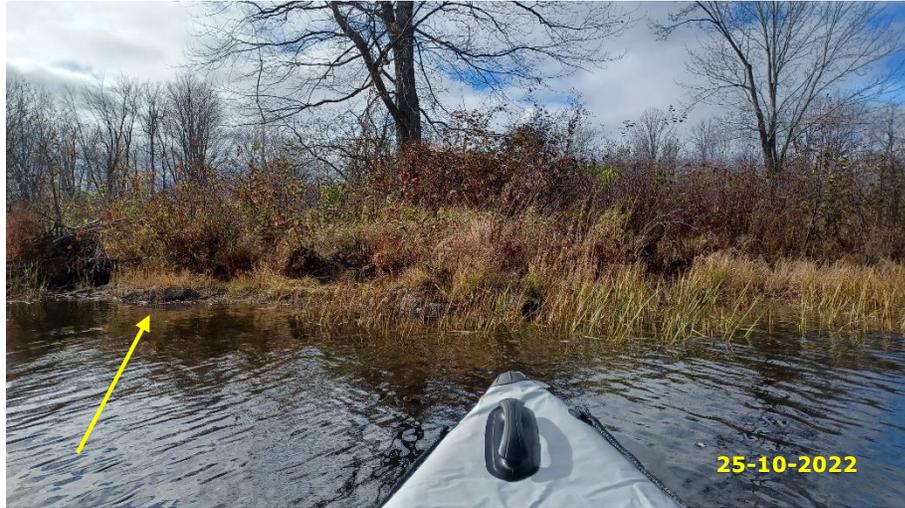
Photo 9
Tay River

Bedrock outcrop (yellow arrow) along the southwest bank.

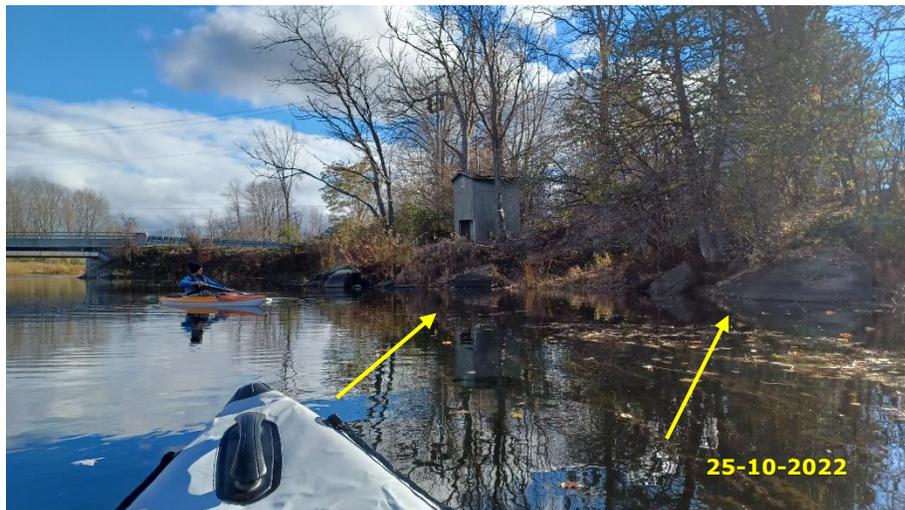
Photo 10
Tay River

Bedrock outcrop (yellow arrows) along the west bank upstream of the Peter St. bridge crossing; perspective is facing southwest downstream.

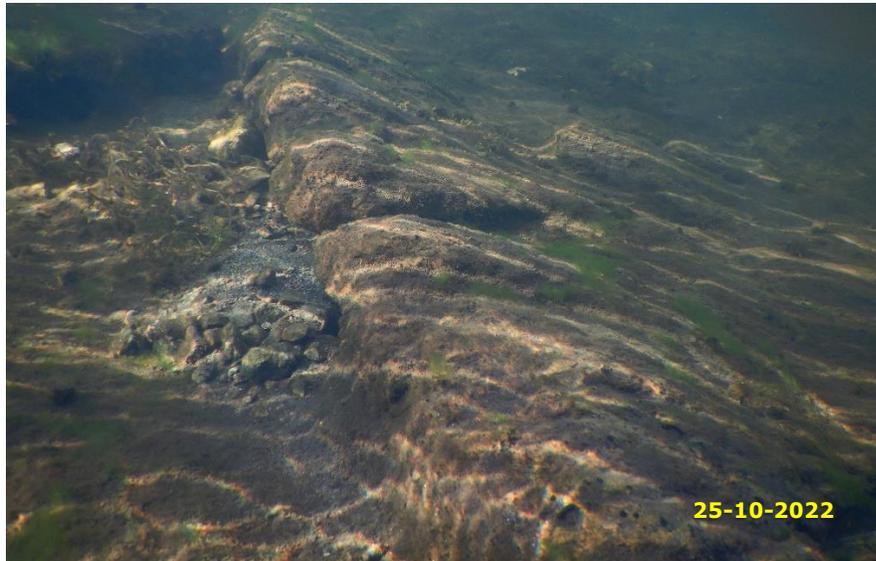
Photo 11
Tay River

Bedrock along the channel bed.

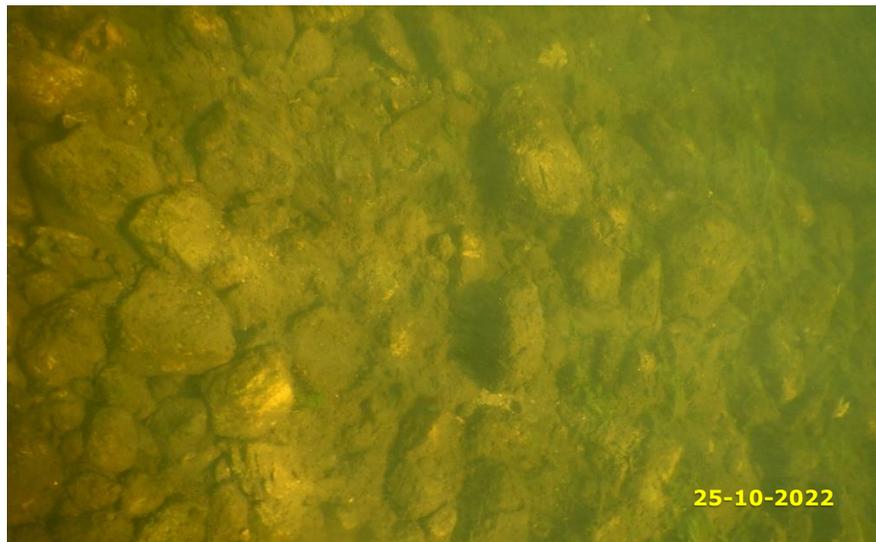
Photo 12
Tay River

Cobble and boulder-sized substrate along the channel bed.
